## Kenwood TS450S AT KC3YFZ Ed Dec 6 2025

**C104 Capacitor if volumn is low on speaker out & replace Lithium Coin battery**  
Common repair 470uF at 25volts. Original was 10 Volts and will get spiked at 14 volts.  
25 volts adds room. The leak will be on bottom. Clean well.

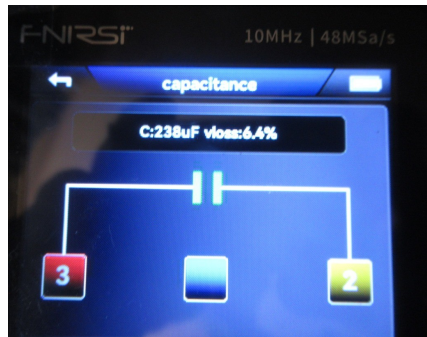
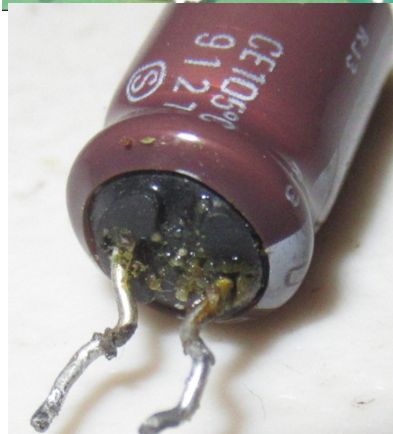
TEST of old came in avg of 267uF it is a 10V cap original. Cap was leaking at bottom.

Kenwood TS-450S IF unit board are as follows: Fails due to 13.9 V spikes. Replae with 25 V.

•**C101:** 470μF at 6.3V not tested no leaks **C99:** 330μF at 25V (tested as 331 uF vLoss 1.9% esr 0.11) **C104:** 470μF at 10V (tested as below 275uF, vLoss 5.8 leaking)

It is highly recommended to replace these original capacitors with new ones that have a higher voltage rating, such as **470 $\mu$ F at 25V**. This is because the original 10V capacitors are considered to be underrated for the circuit's operating voltage, which is around 14V, leading to their common failure over time.
