kenwood ts 850 s at 1991 sold date

Disply board 1 cap leaked took out 4 traces

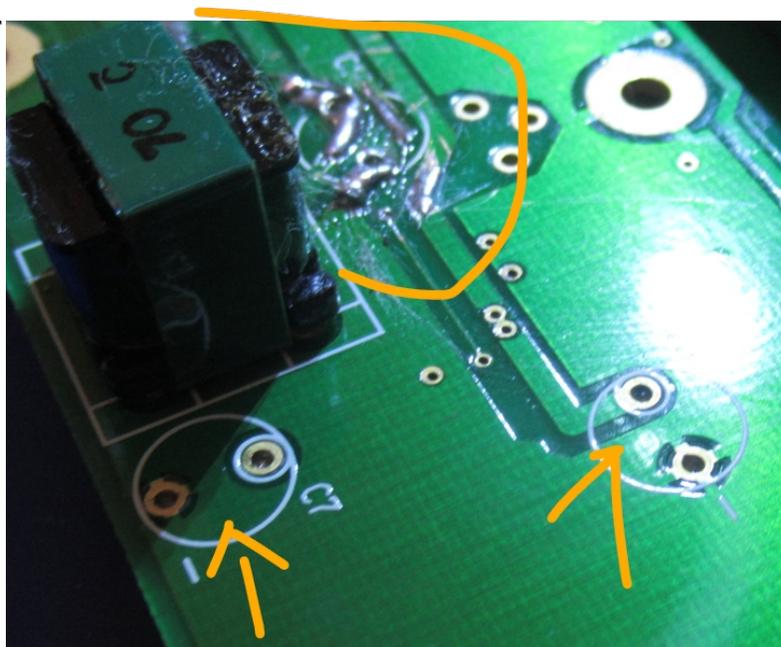
Same for a few solder joints needed this.

trick if the color of solder is dark grey add flux add new solder, then wick all until shiny

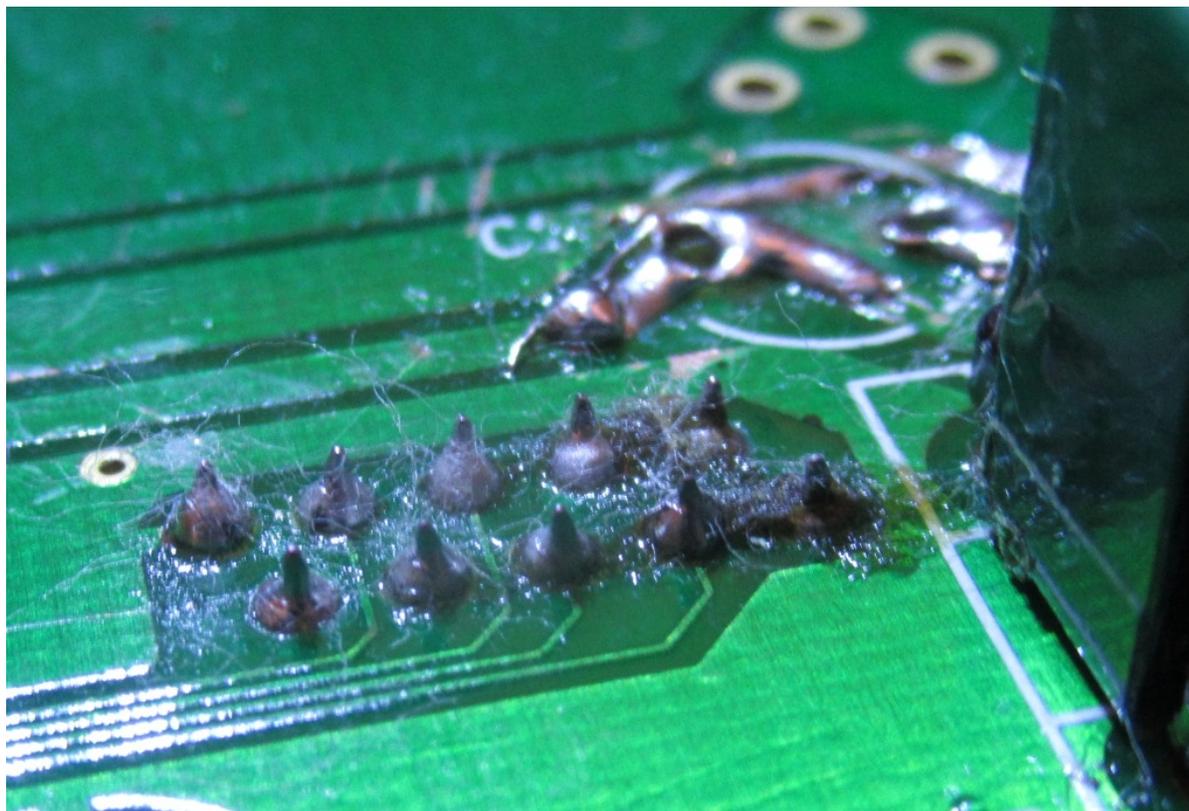
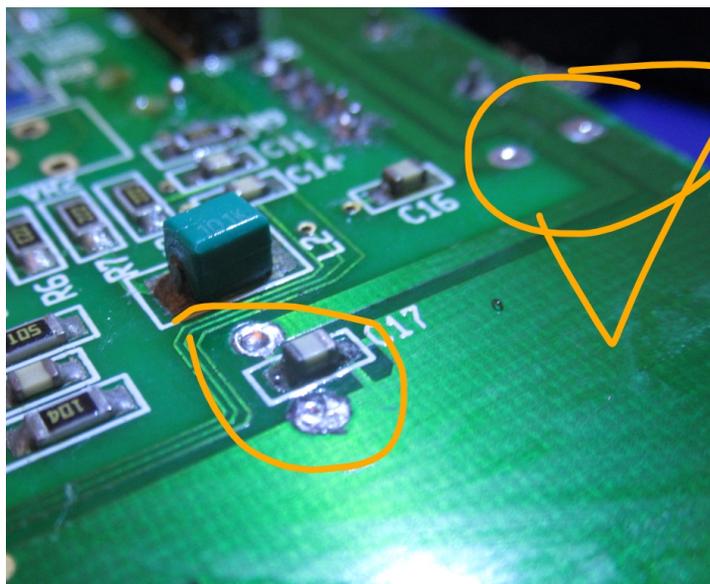
needs resolder leaked and destroyed the joint. flux, new solder, wick, suck. see the color of solder. takes time to clean it

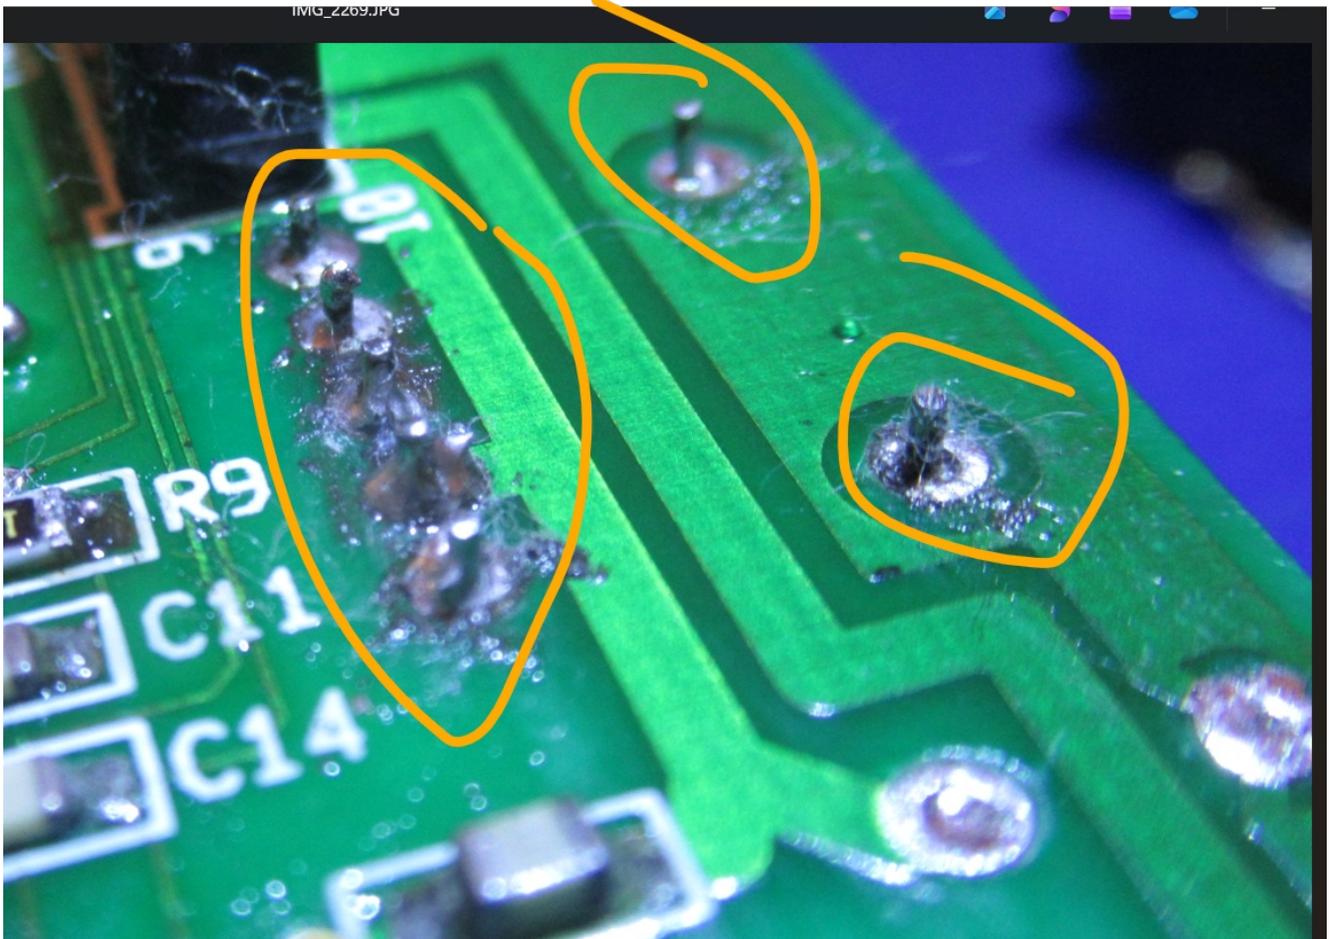
These were dark, same process but nice and ready for new flux and solder.

This board will be complete. Then test. Best if the system works before, only do one board at a time to help isolate issues.

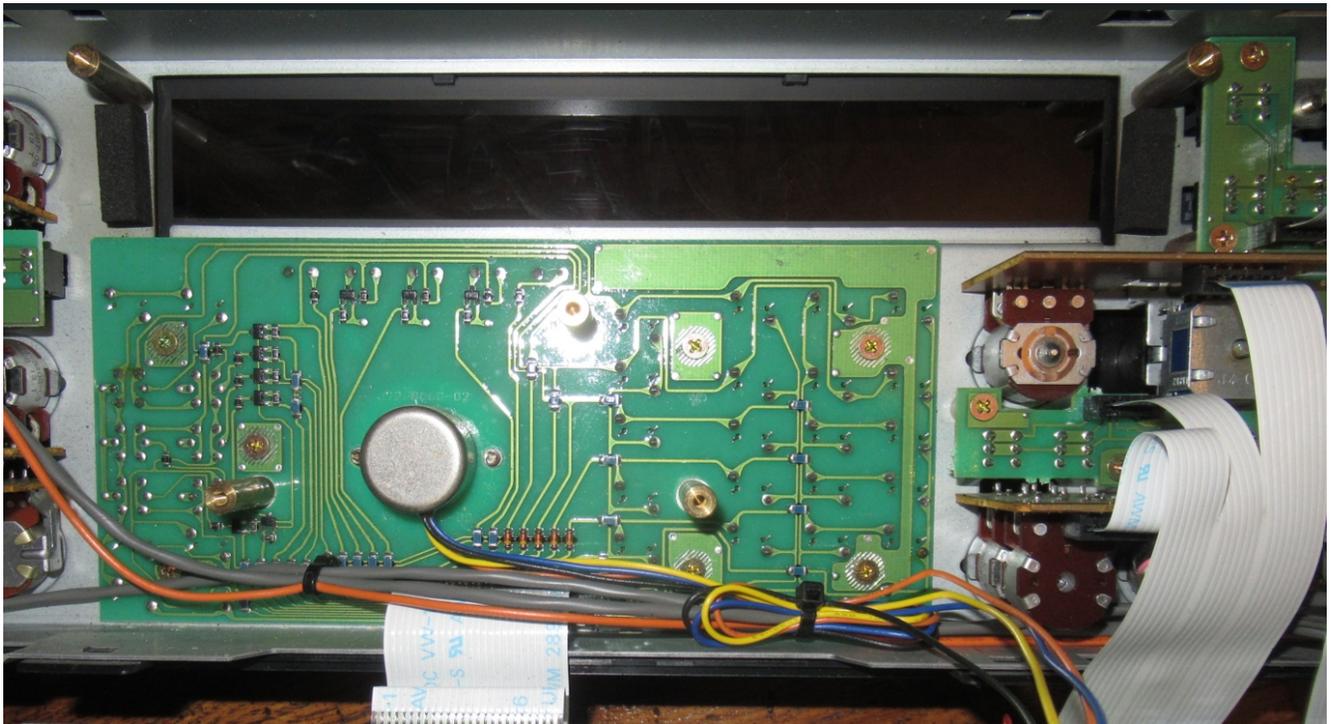
the display board fits fine with 25 V radial caps

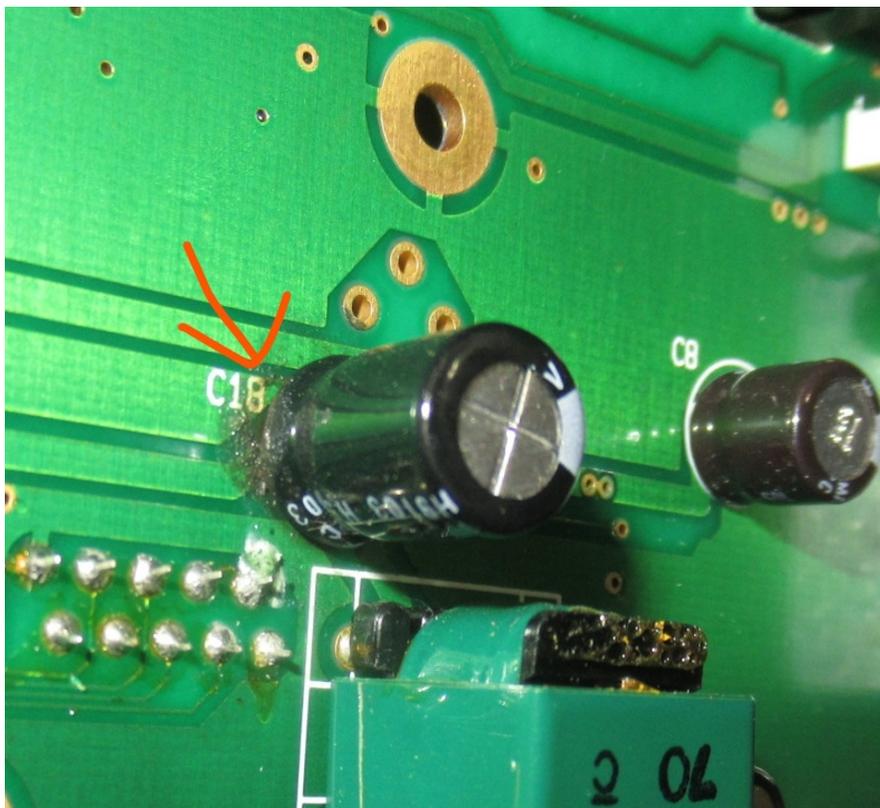
recapped and traces fixed  
before:

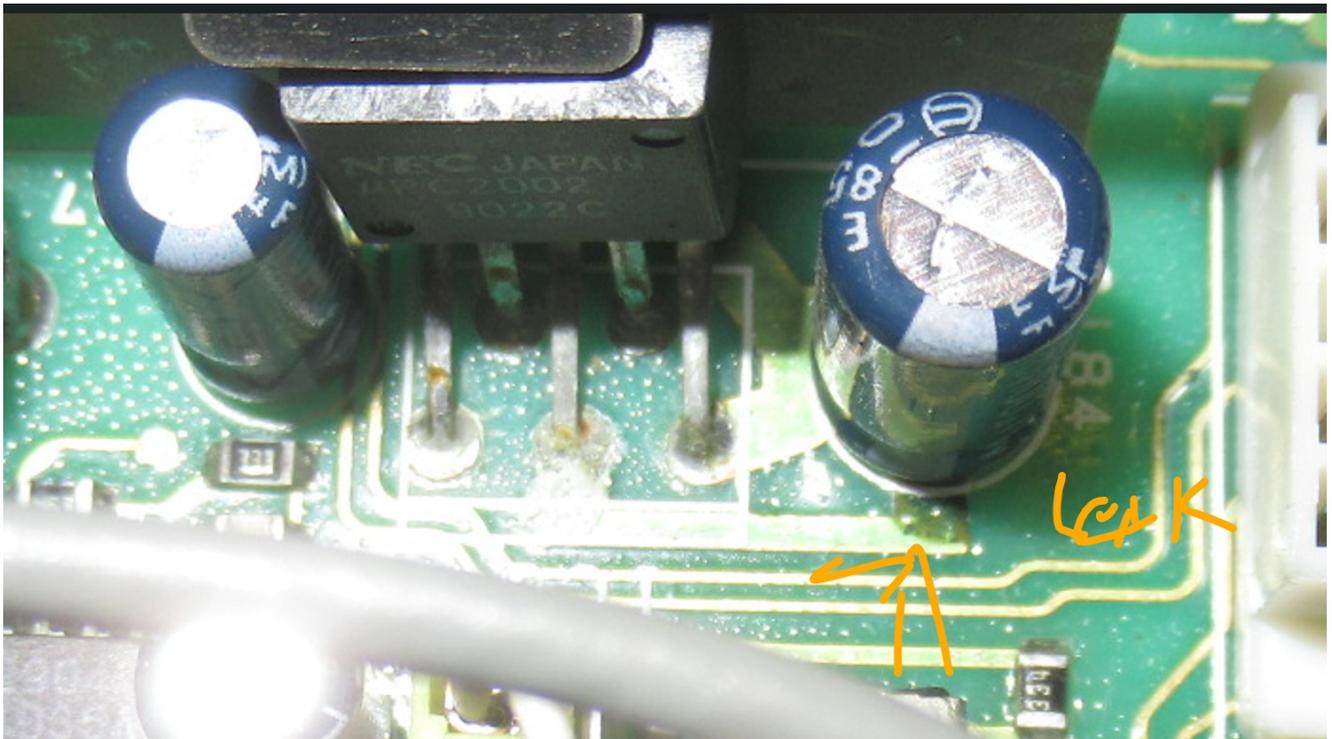
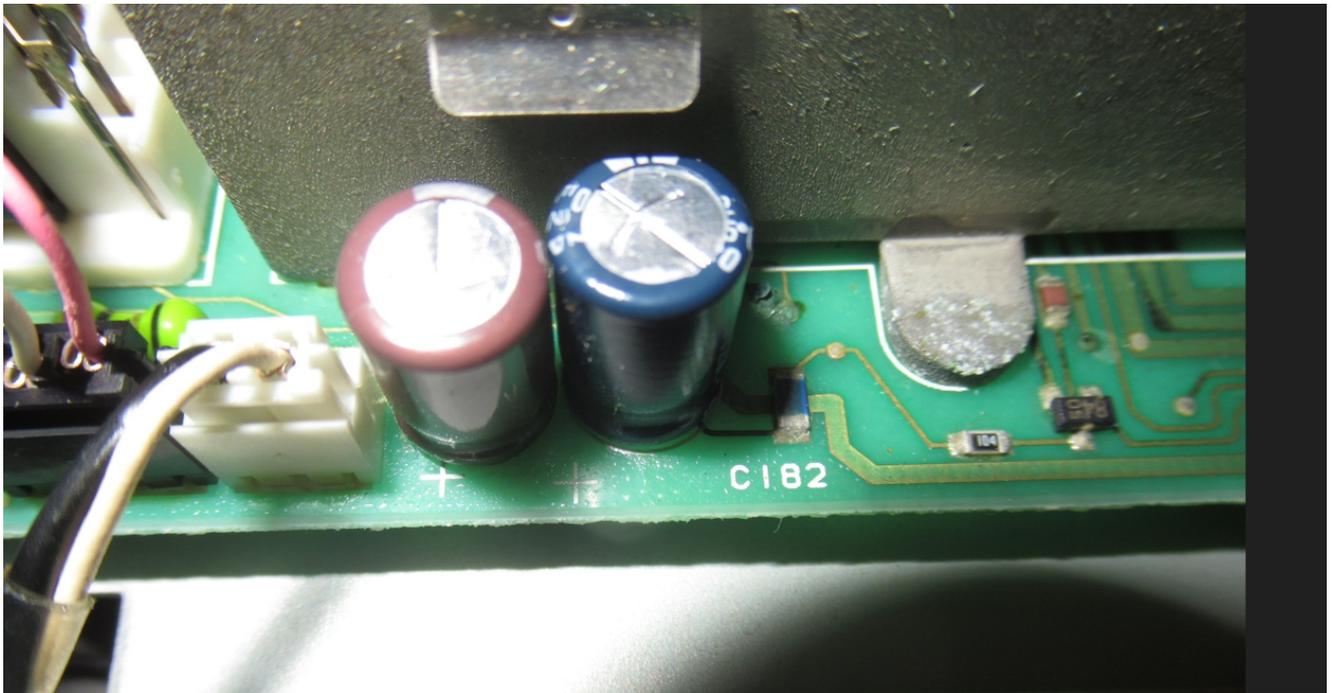
main board needs a few caps. leaky as normal.

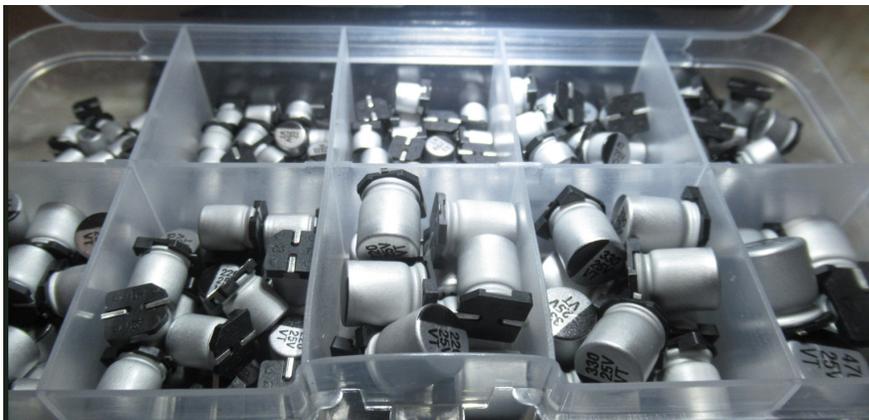
CAR (carrier board) 11 SMD Aluminum caps and the Main board for 2 Radial caps
